DOT/FAA/AR-95/108

Characterization of Early Stages of Corrosion Fatigue in Aircraft Skin

February 1996

Final Report

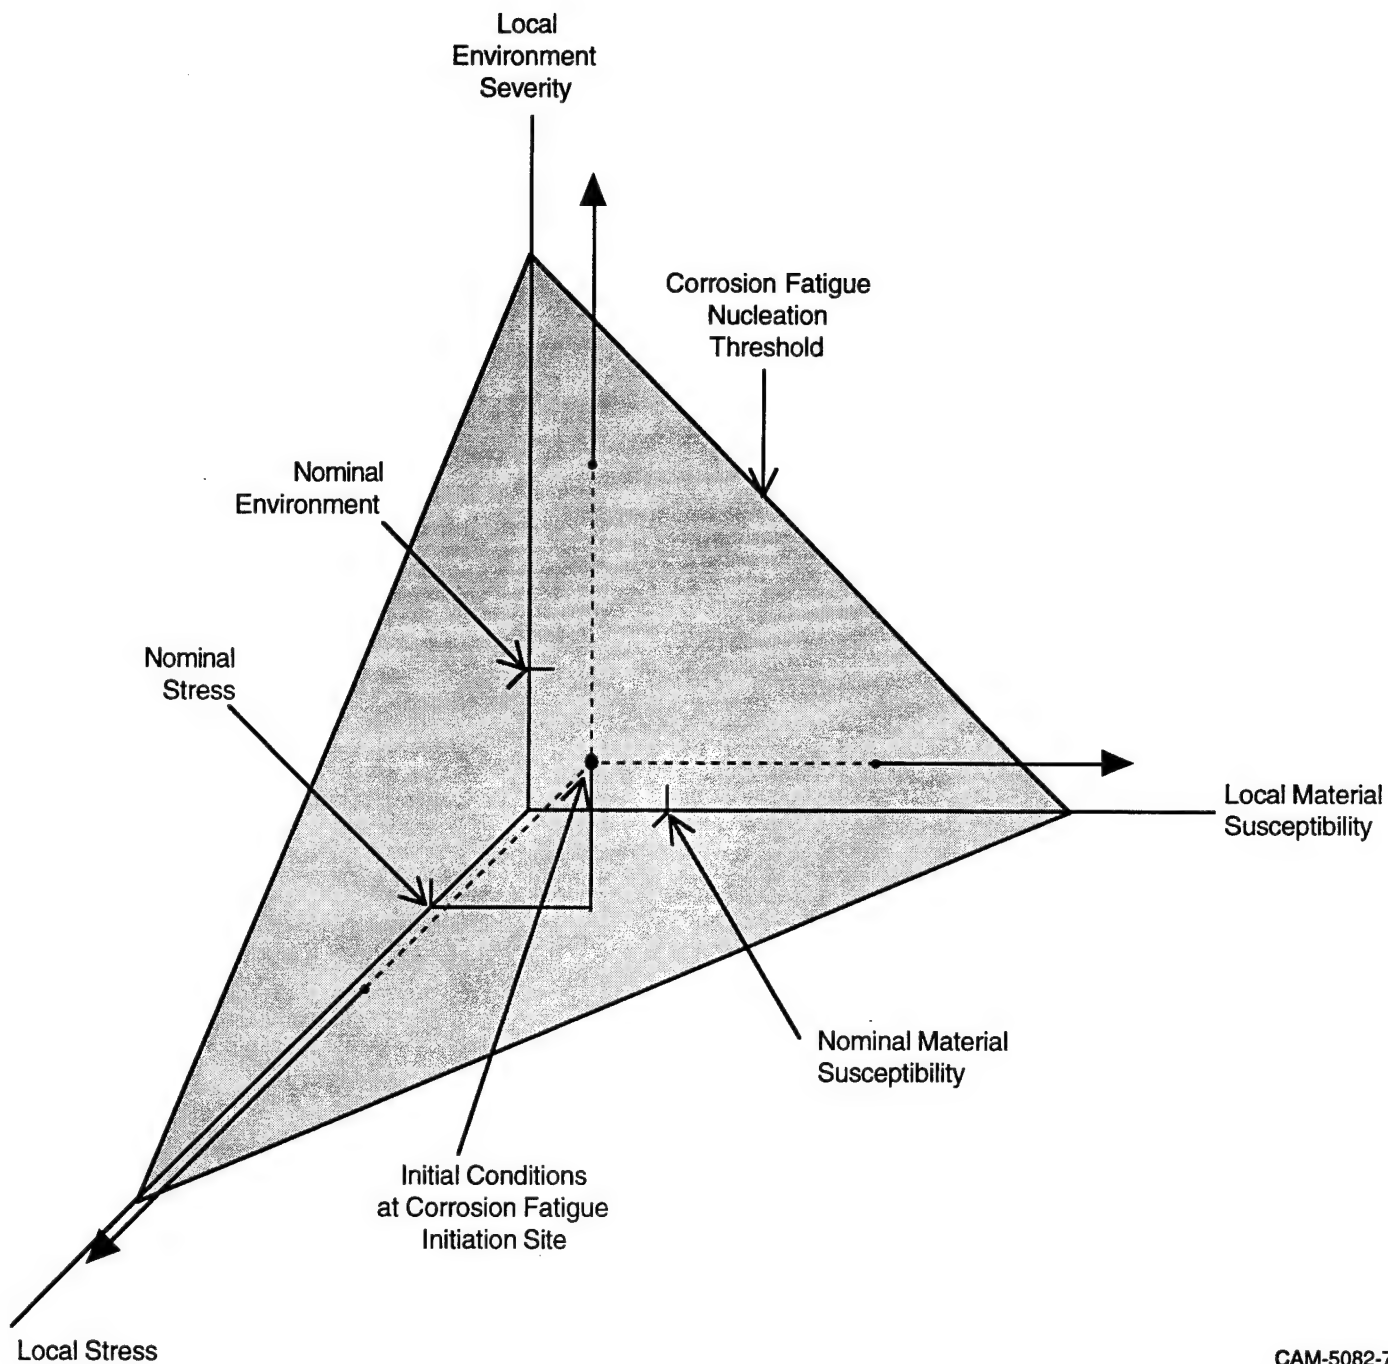
CAM-5082-7

Figure 1. Critical conditions for corrosion-fatigue crack nucleation.

This is illustrated in figure 1, where the conditions for fatigue crack formation are depicted as a surface in three-dimensional space defined by axes of local stress, local material susceptibility, and local environment severity. The figure depicts a point in space representing initial conditions where crack nucleation does not occur. As conditions change over time, the local conditions could follow a wide range of trajectories that represent different combinations of change in the local stress, material susceptibility, and environment.

Most models of corrosion-fatigue crack nucleation¹⁻⁵ focus on the changes in local stress that result from pitting. This is equivalent to following a trajectory of increasing local stress that parallels the local stress axis in figure 1. In such models, a critical condition is assumed to occur when the stress intensity produced by the pit is of a sufficient magnitude for cracks to nucleate. The inherent assumption in this approach is that conditions of material susceptibility and environment do not change over time. This assumption might be unrealistic. However, a more comprehensive understanding is needed if a range of interactions between environment, stress, and material susceptibility are to be considered. Such analyses have been attempted and, at least in one case,³ a quantitative description of how the critical pit size is affected by the environment has been proposed.

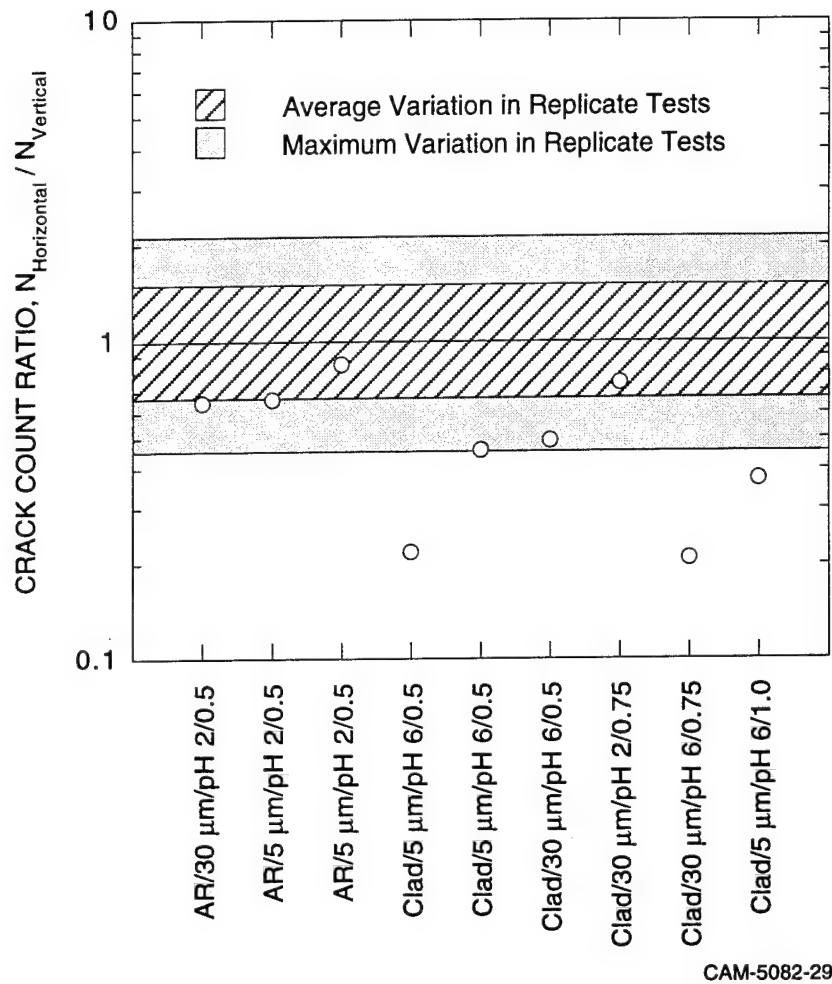
Figure 22. Effect of specimen orientation on the number of cracks.

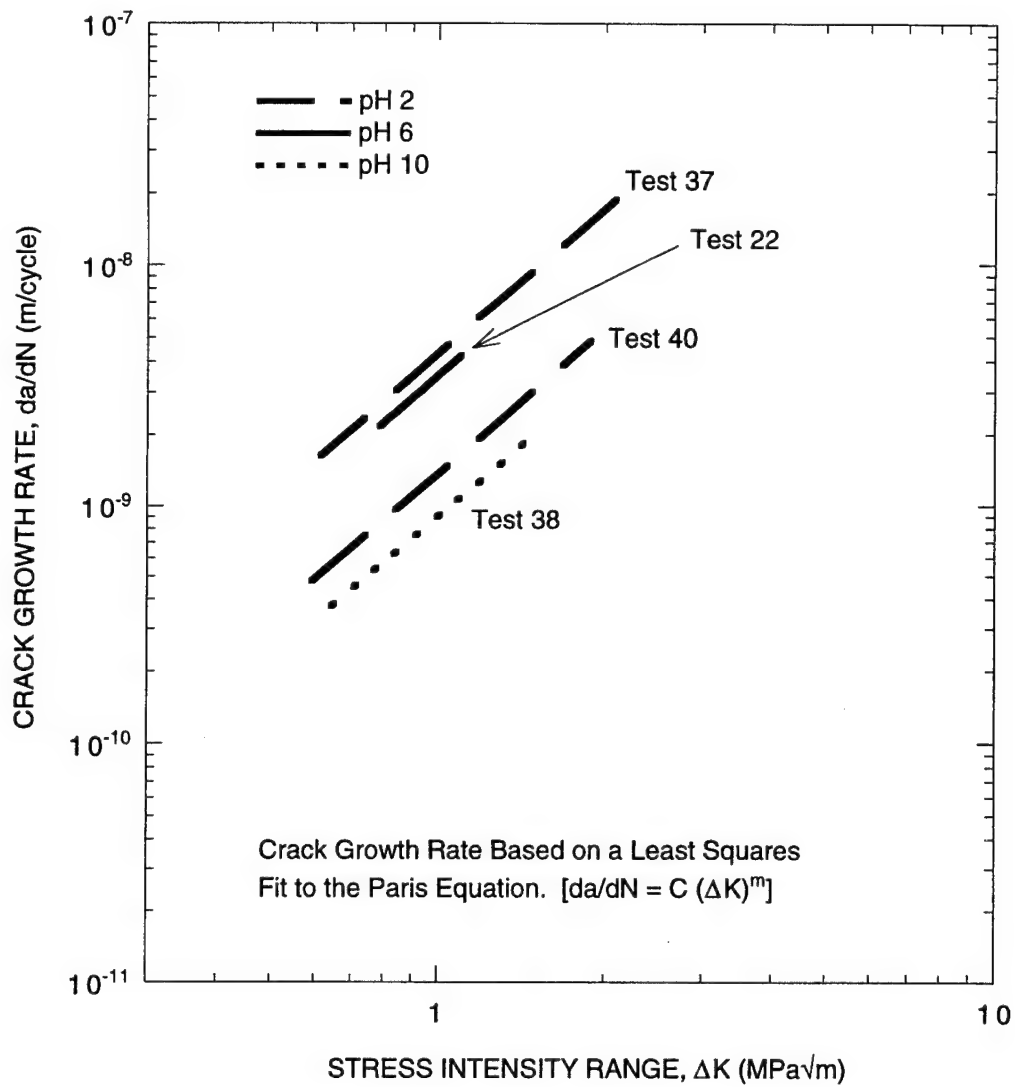
(a) Comparison of specimens in the vertical orientation in the as-received condition with a 5 μm polish on the through-thickness surfaces

Figure 26. Effect of pH on the crack growth rate of small cracks in aircraft skin.

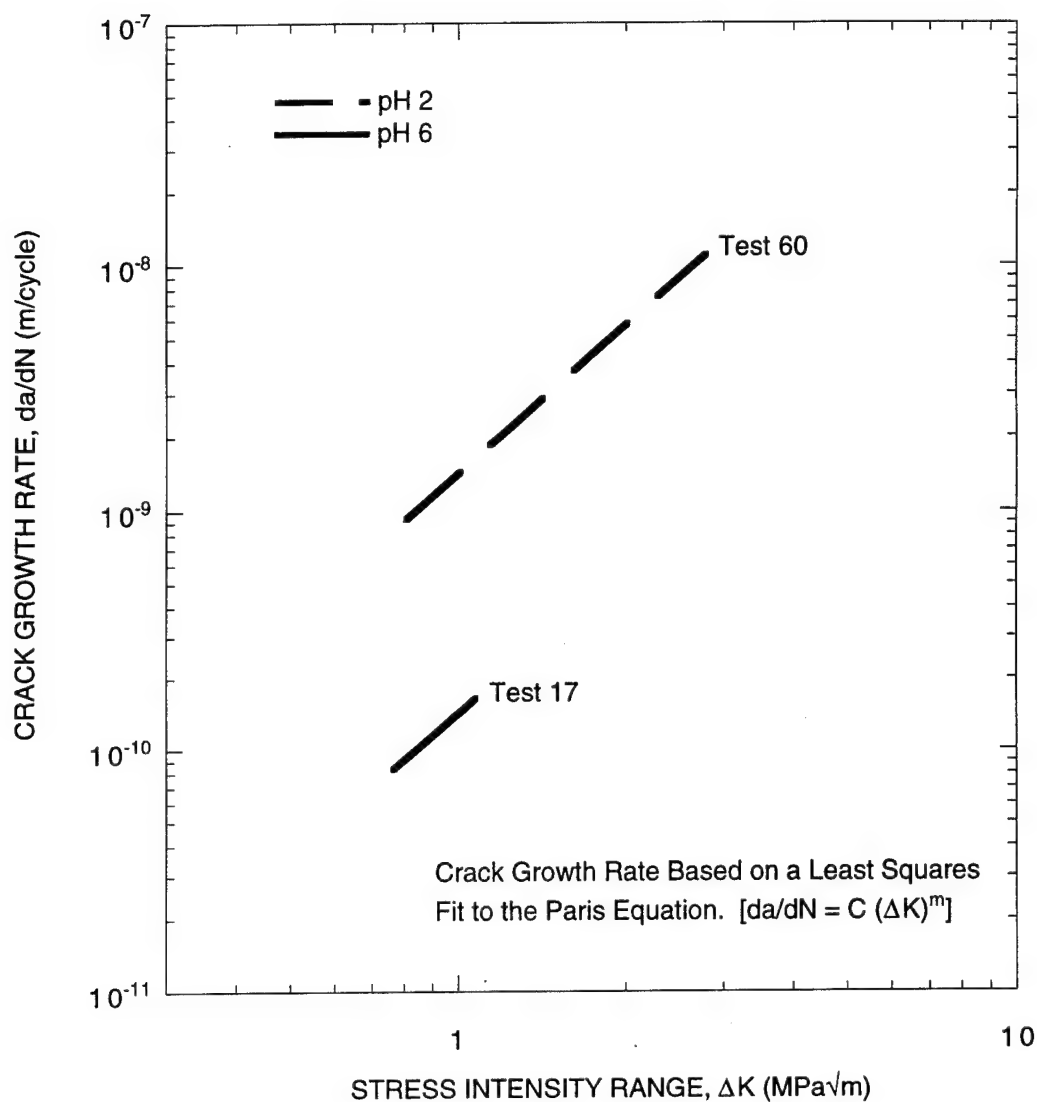
(b) Comparison of specimens in the vertical orientation in the clad-only condition with a 5 μ m polish on the through-thickness surfaces

Figure 26. Effect of pH on the crack growth rate of small cracks in aircraft skin (Continued).

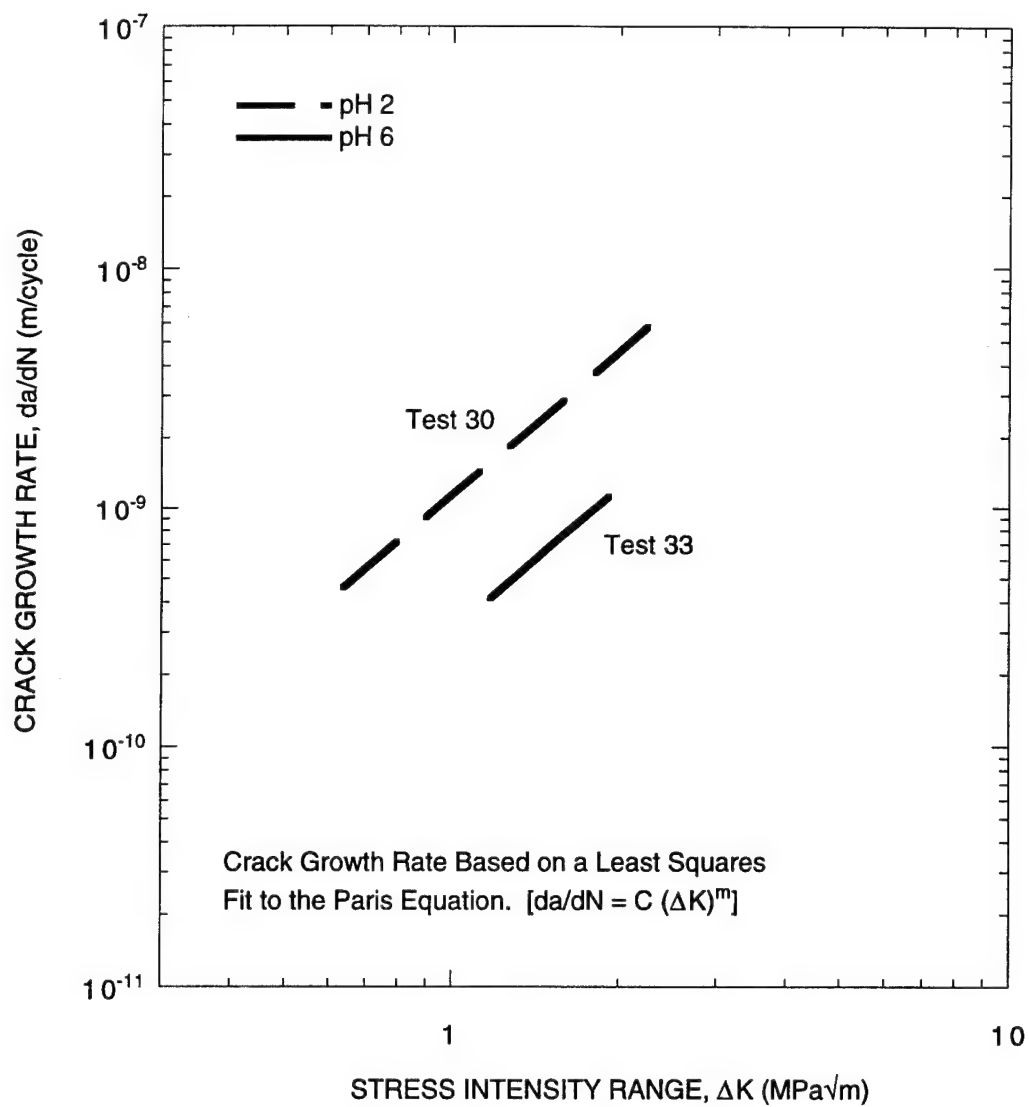
(c) Comparison of specimens in the vertical orientation in the as-received condition with a 30 μm polish on the through-thickness surfaces

Figure 26. Effect of pH on the crack growth rate of small cracks in aircraft skin (Continued).

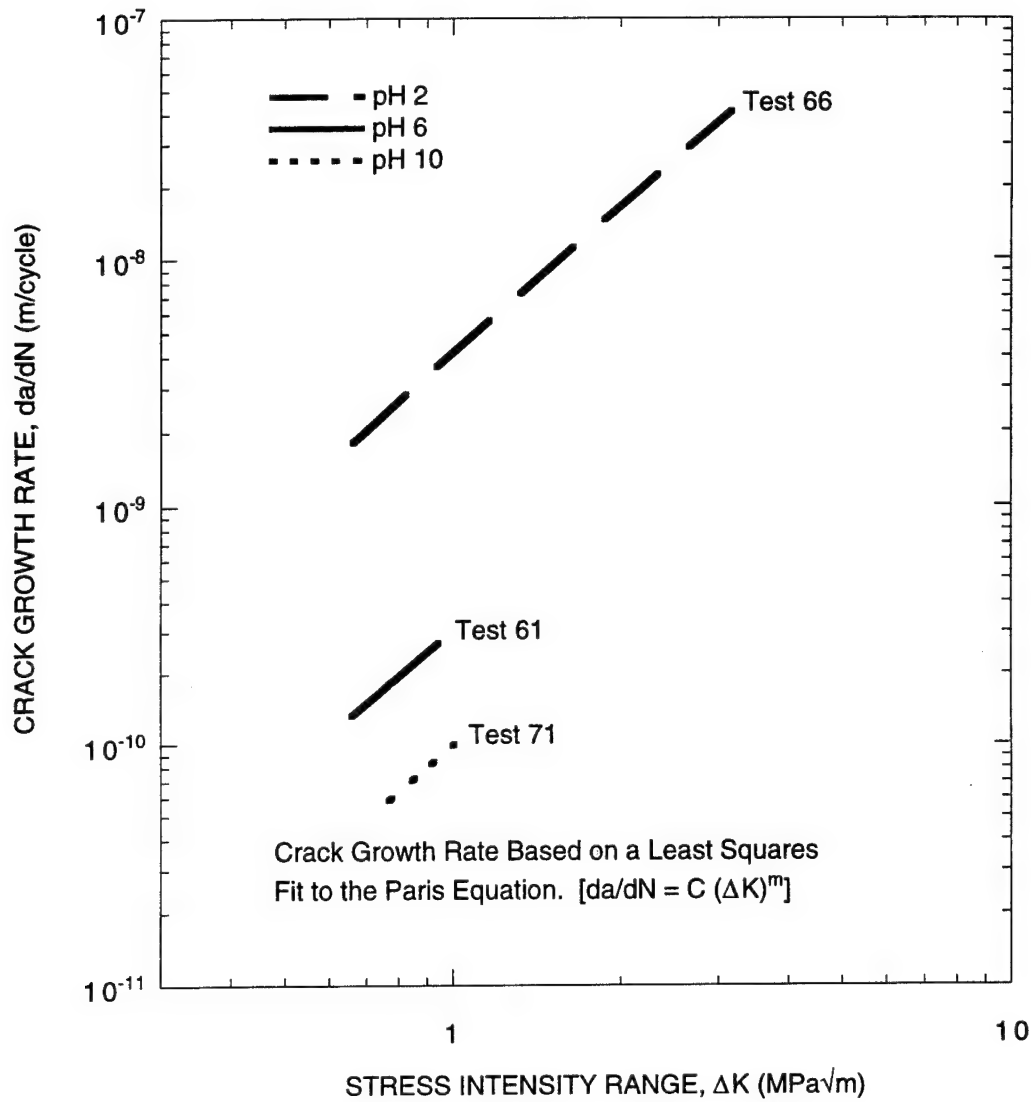
(d) Comparison of specimens in the horizontal orientation in the as-received condition with a 5 μm polish on the through-thickness surfaces

Figure 26. Effect of pH on the crack growth rate of small cracks in aircraft skin (Continued).

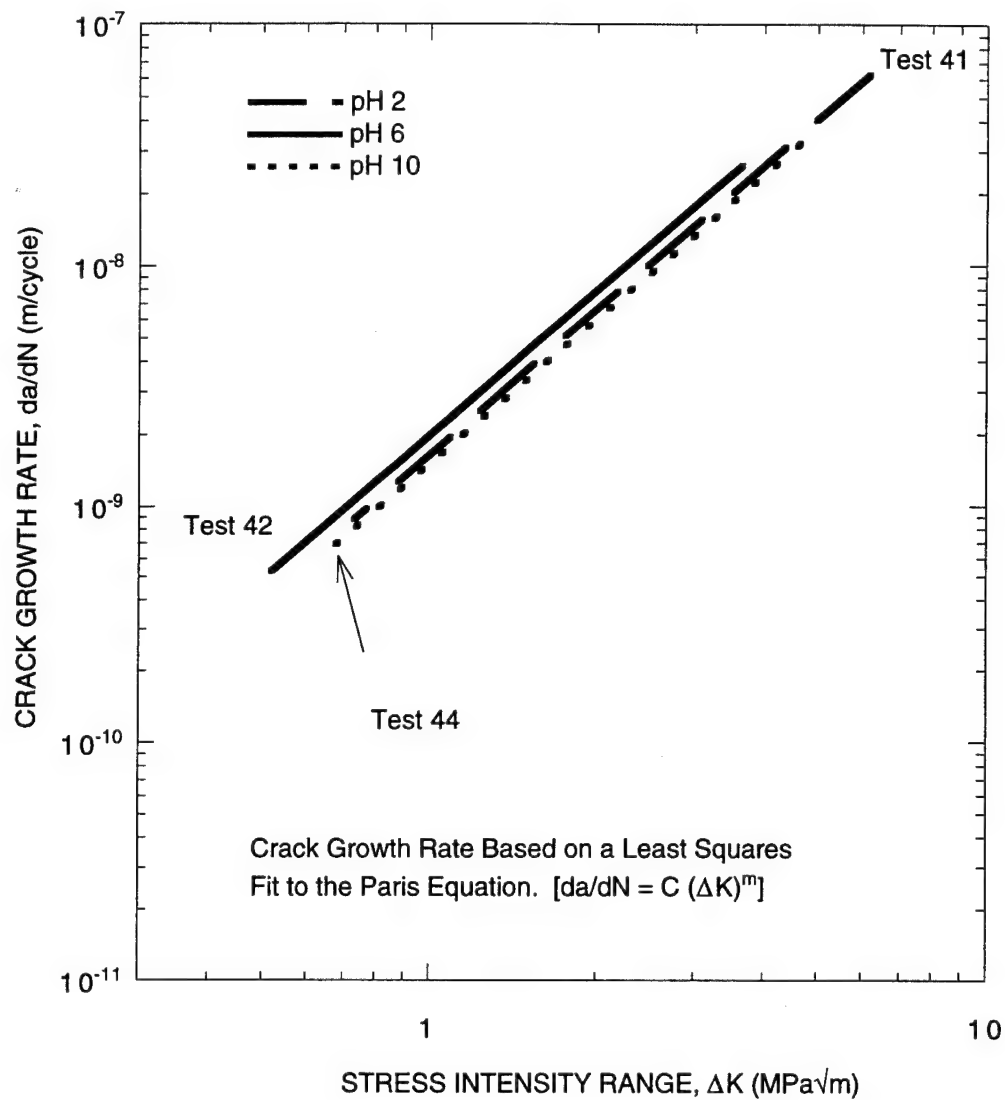
(e) Comparison of specimens in the horizontal orientation in the as-received condition with a 30 μm polish on the through-thickness surfaces

Figure 26. Effect of pH on the crack growth rate of small cracks in aircraft skin (Continued).

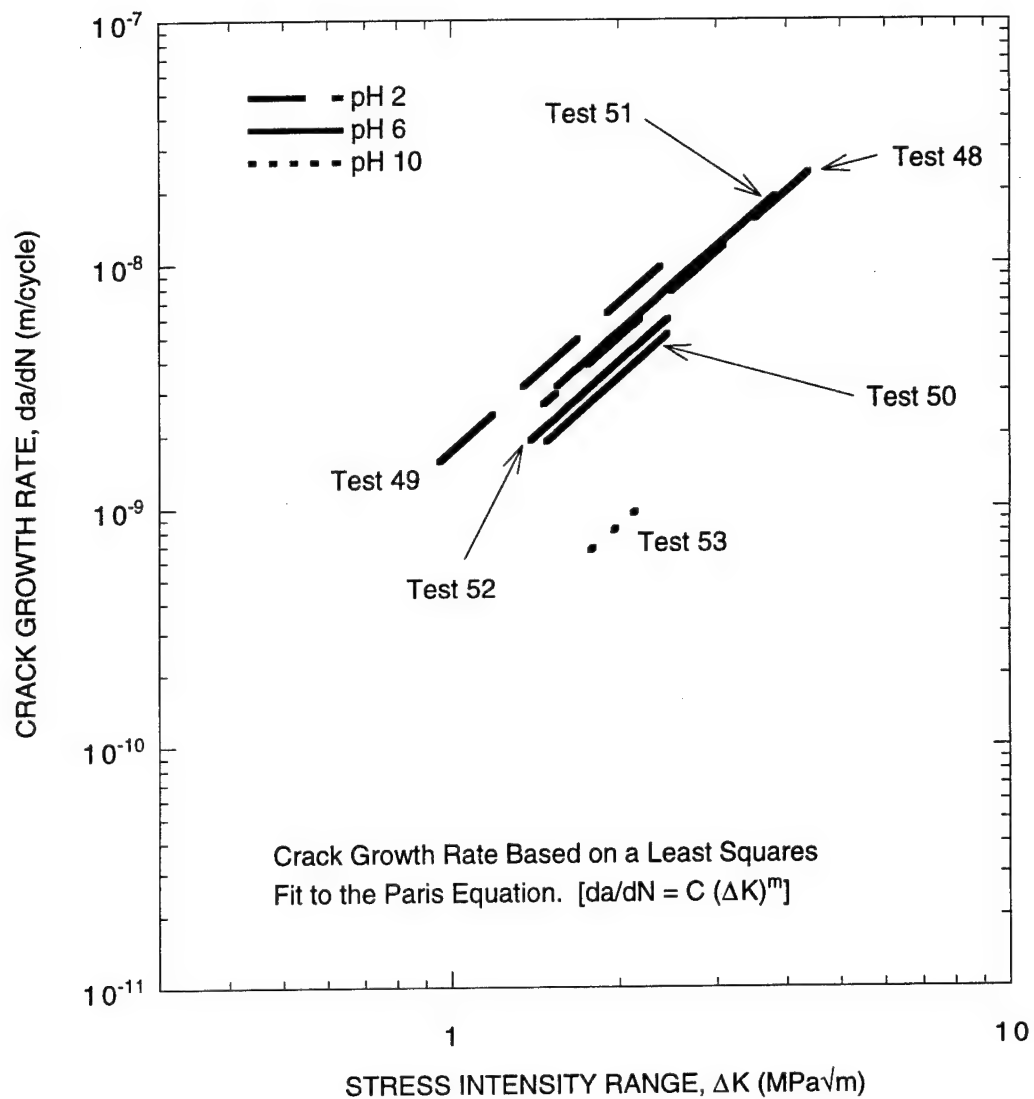
(f) Comparison of specimens in the horizontal orientation in the clad-only condition with a 30 μm polish on the through-thickness surfaces

Figure 26. Effect of pH on the crack growth rate of small cracks in aircraft skin (Concluded).

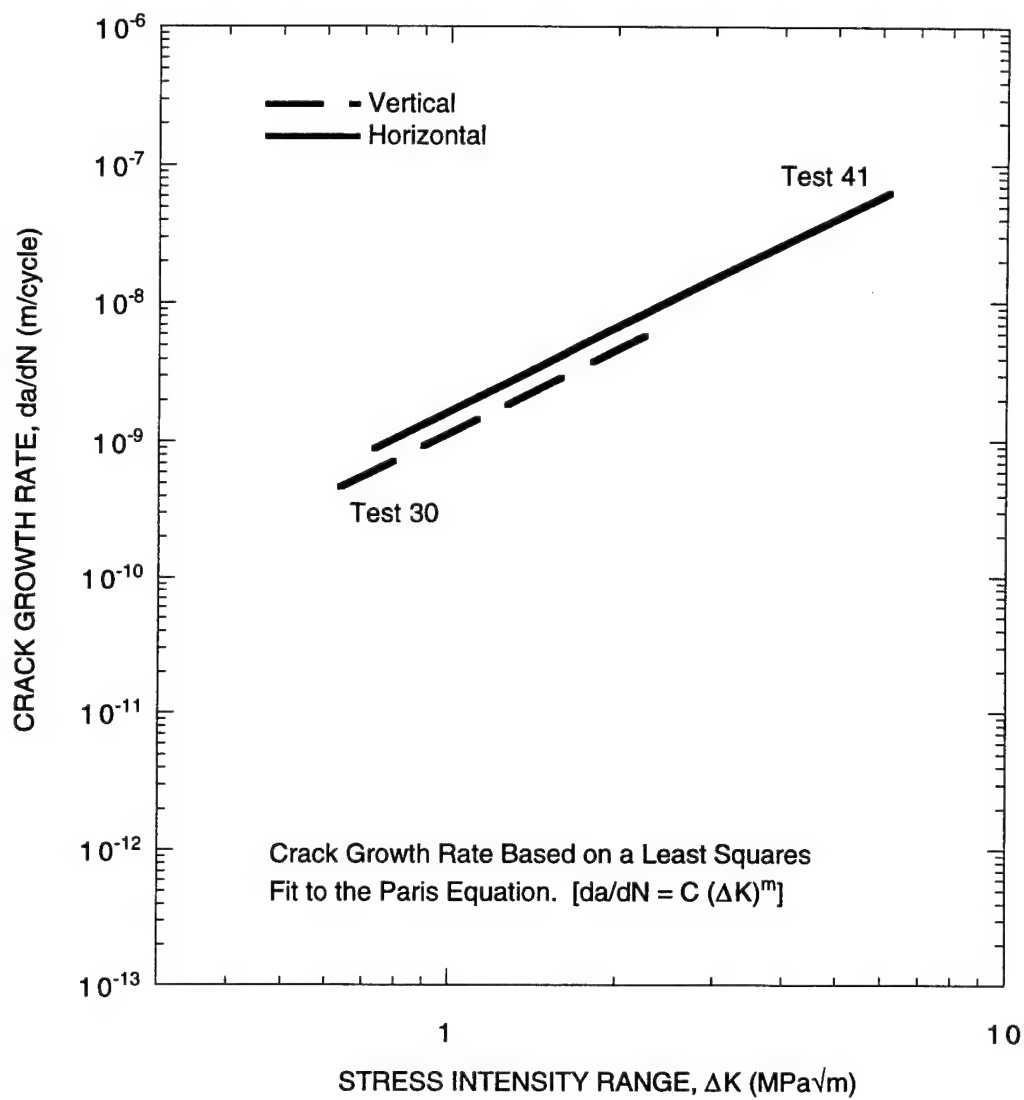
(a) Comparison of specimens in the as-received condition with a 30 μm polish on the through-thickness surfaces in the pH 2 environment

Figure 27. Effect of orientation on the crack growth rate of small cracks in aircraft skin.

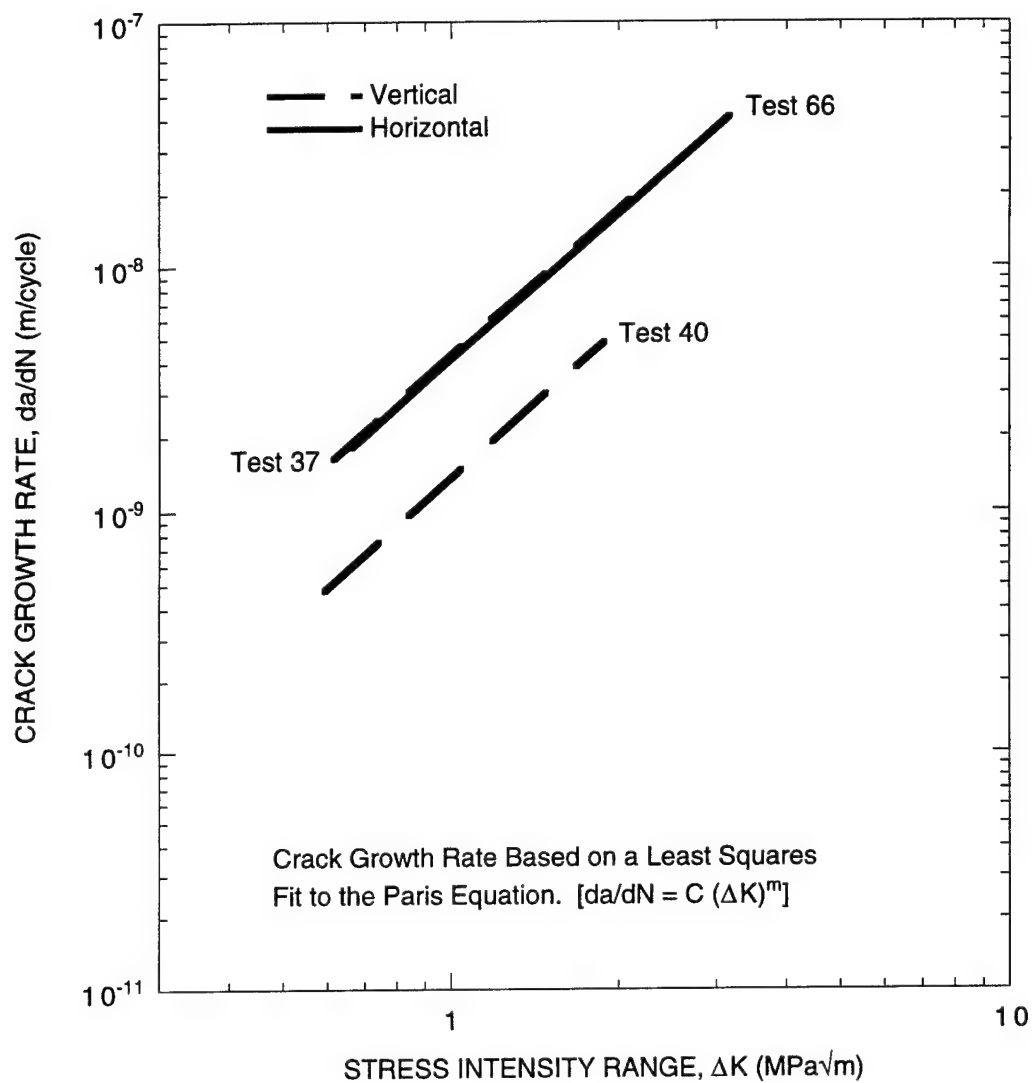
(b) Comparison of specimens in the as-received condition with a 5 μ m polish on the through-thickness surfaces in the pH 2 environment

Figure 27. Effect of orientation on the crack growth rate of small cracks in aircraft skin (Continued).

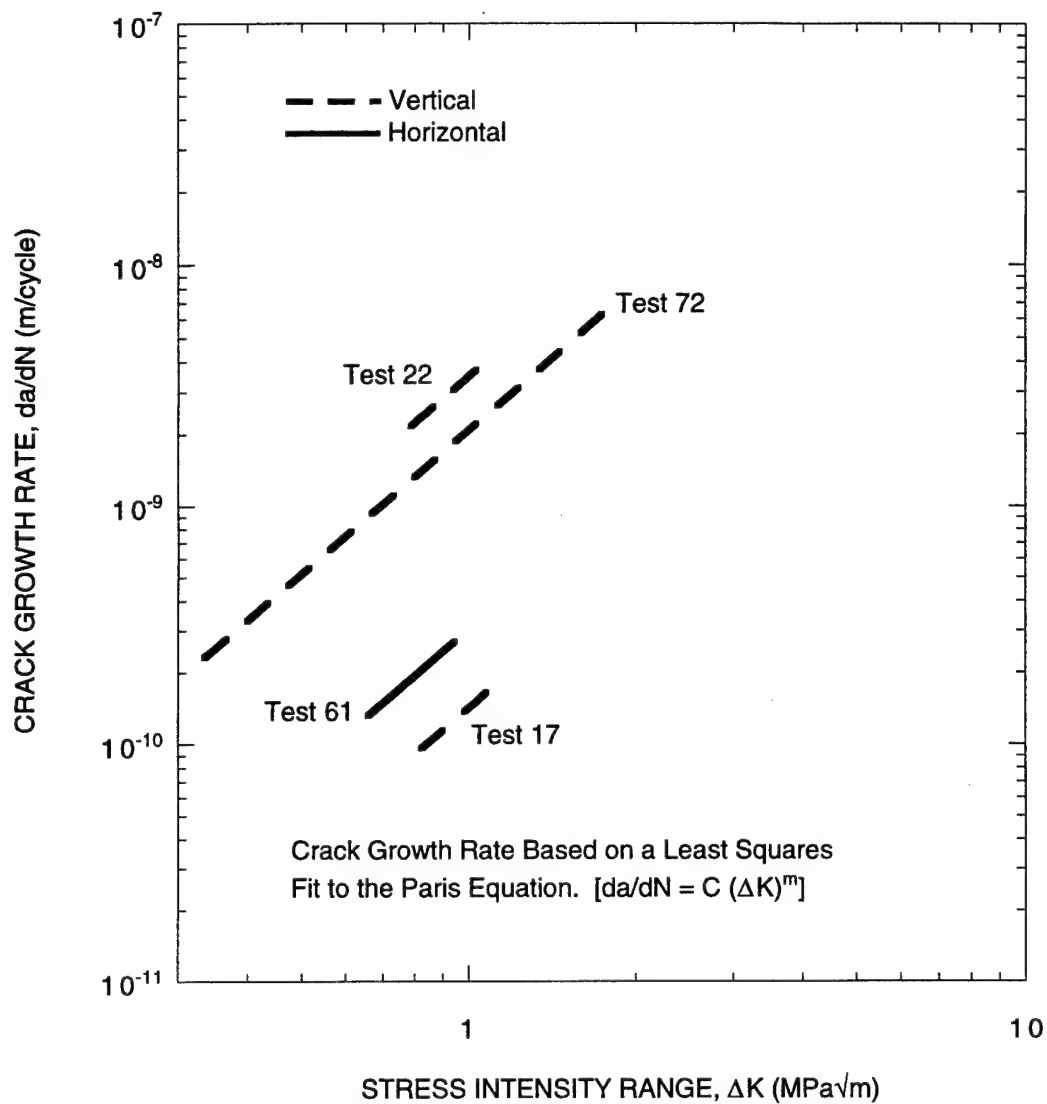
(c) Comparison of specimens in the clad-only condition with a 5 μm polish on the through-thickness surfaces in the pH 6 environment

Figure 27. Effect of orientation on the crack growth rate of small cracks in aircraft skin (Continued).

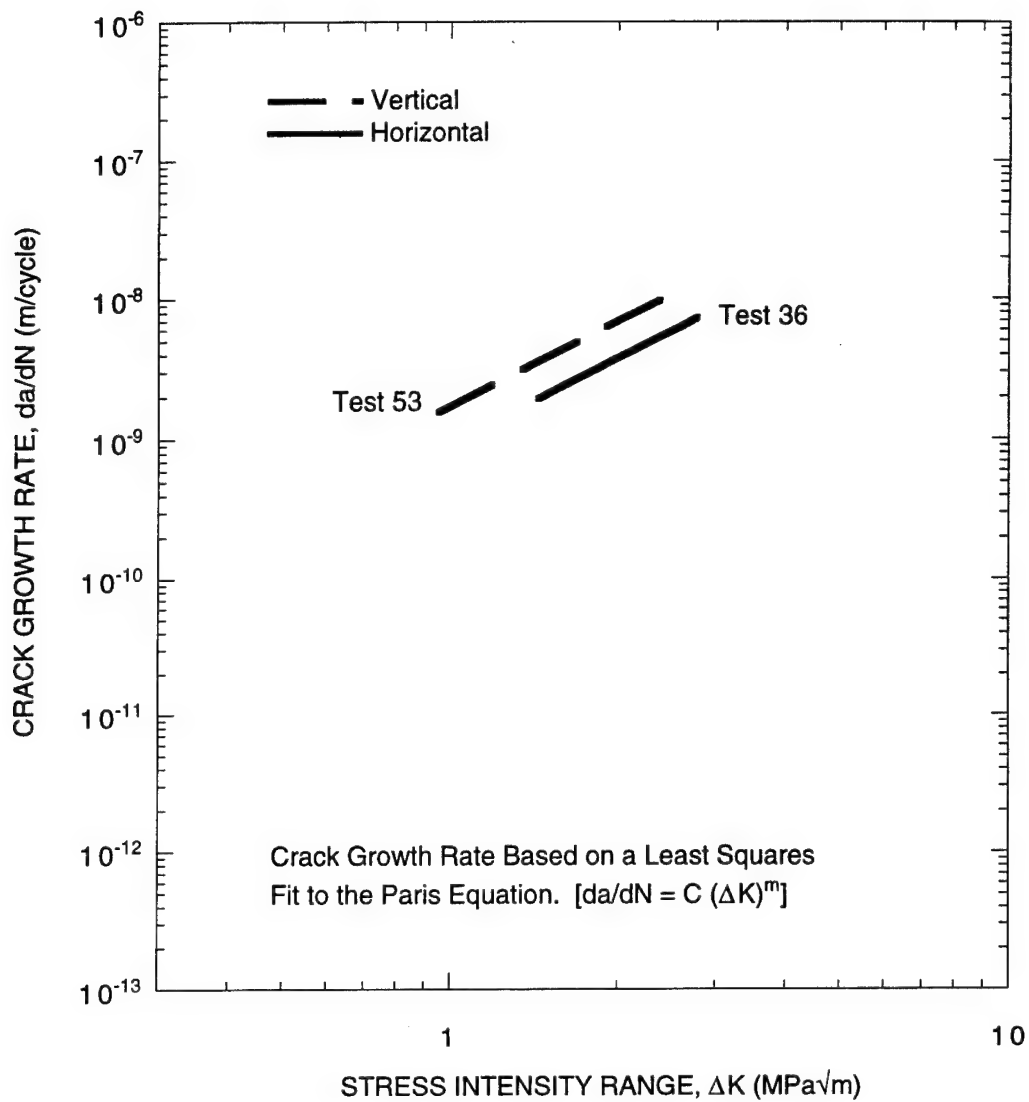
(d) Comparison of specimens in the clad-only condition with a 30 μm polish on the through-thickness surfaces in the pH 2 environment

Figure 27. Effect of orientation on the crack growth rate of small cracks in aircraft skin (Continued).

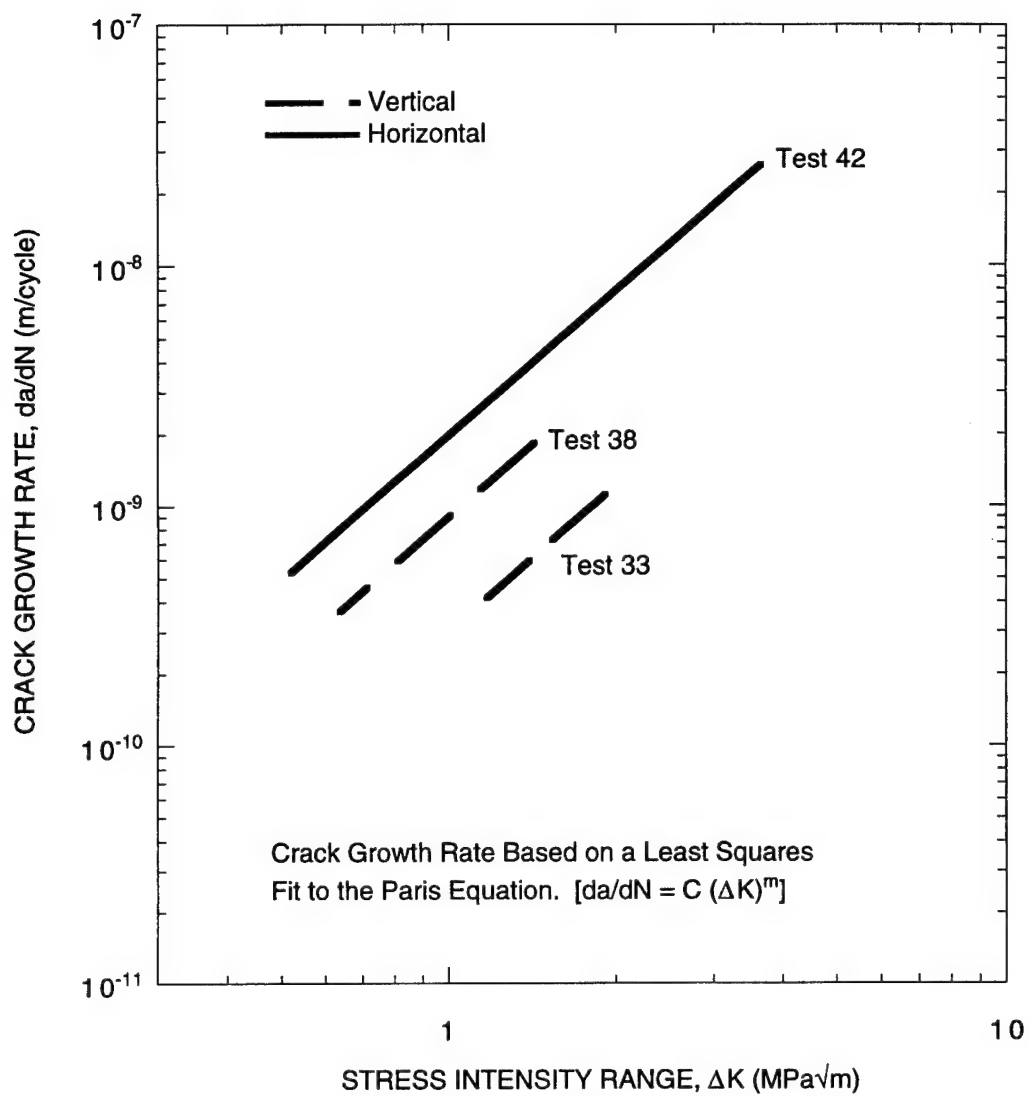
(e) Comparison of specimens in the clad-only condition with a 30 μm polish on the through-thickness surfaces in the pH 6 environment

Figure 27. Effect of orientation on the crack growth rate of small cracks in aircraft skin (Concluded).

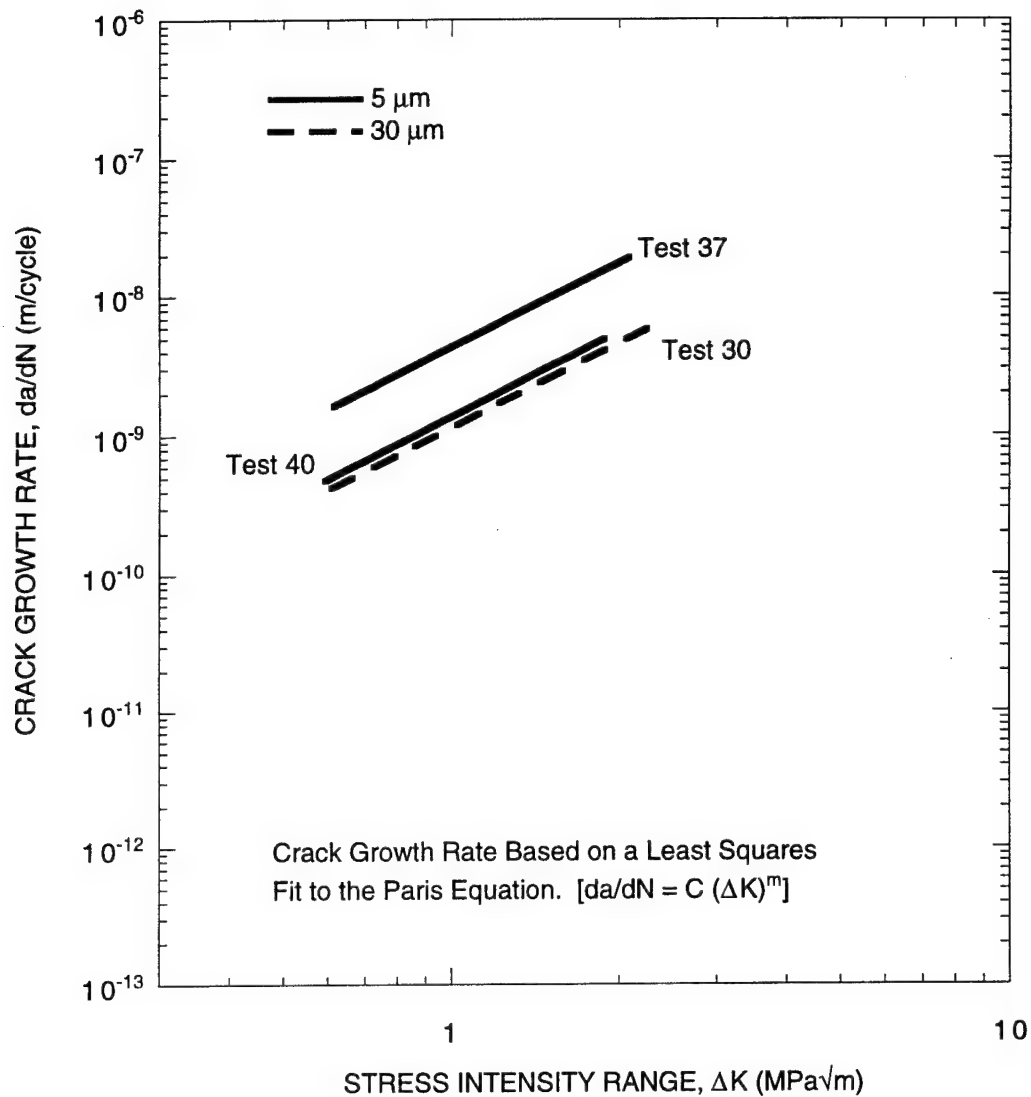
(a) Comparison of specimens in the as-received condition and in the vertical orientation in the pH 6 environment

Figure 28. Effect of surface roughness on the crack growth rate of small cracks in aircraft skin.

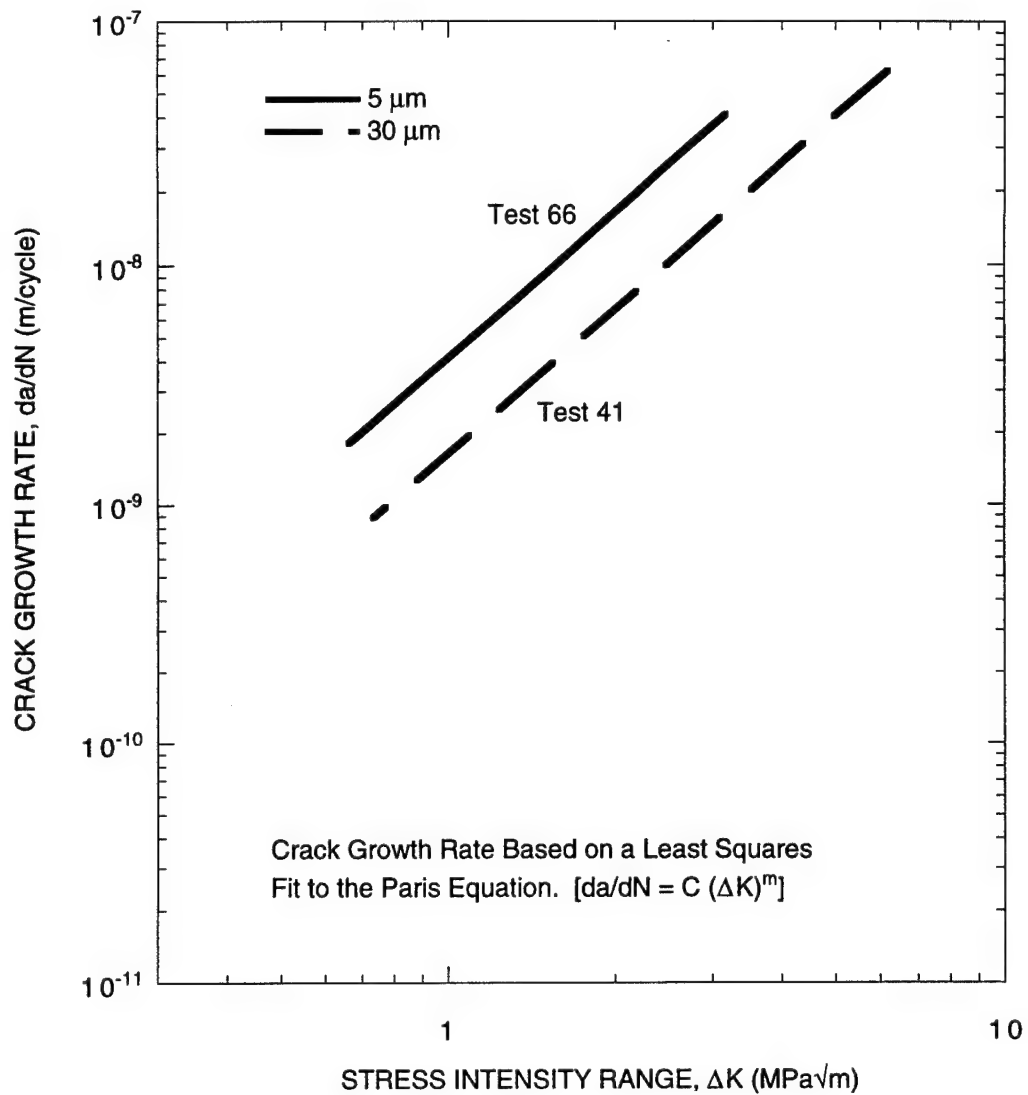
(b) Comparison of specimens in the as-received condition and in the horizontal orientation in the pH 2 environment

Figure 28. Effect of surface roughness on the crack growth rate of small cracks in aircraft skin (Continued).

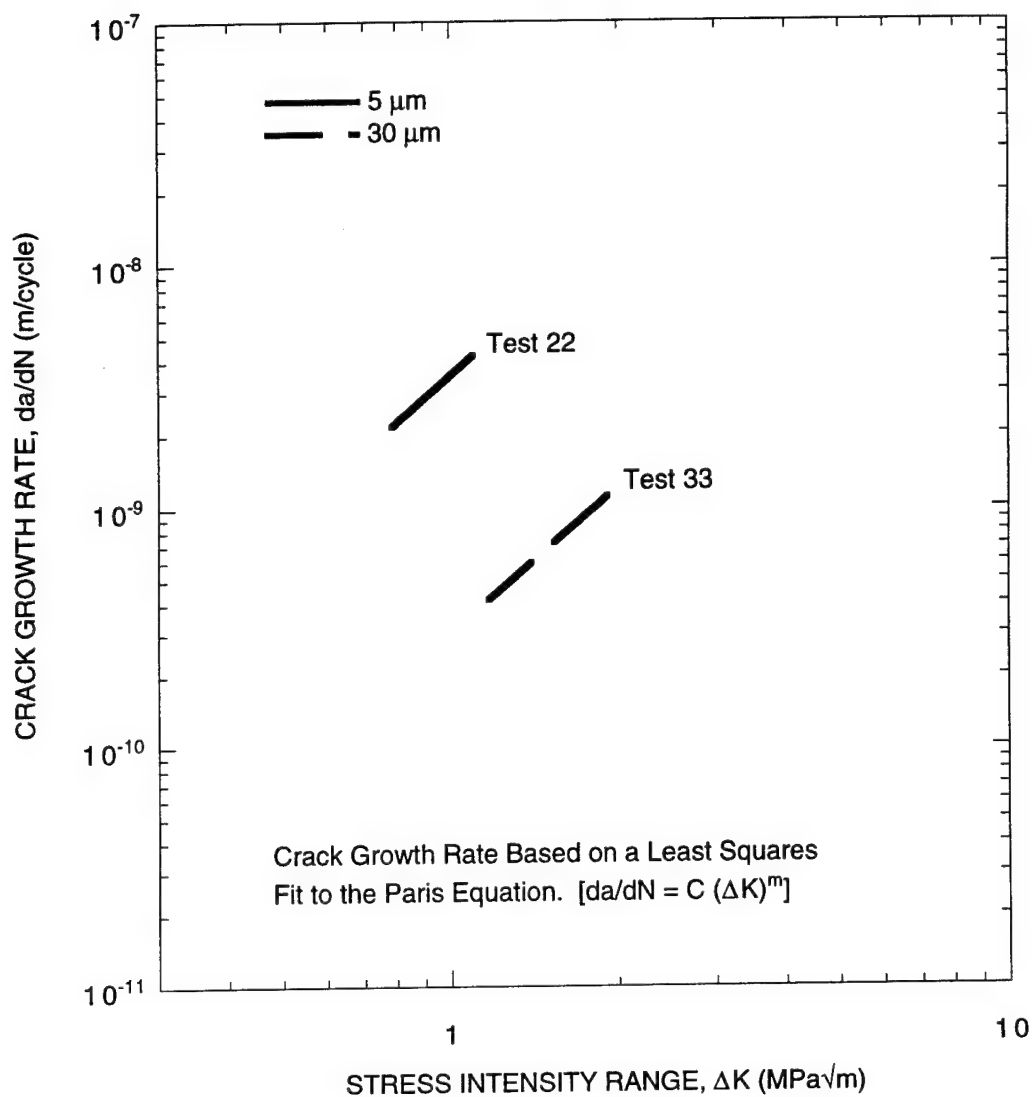
(c) Comparison of specimens in the as-received condition and in the vertical orientation in the pH 6 environment

Figure 28. Effect of surface roughness on the crack growth rate of small cracks in aircraft skin (Continued).

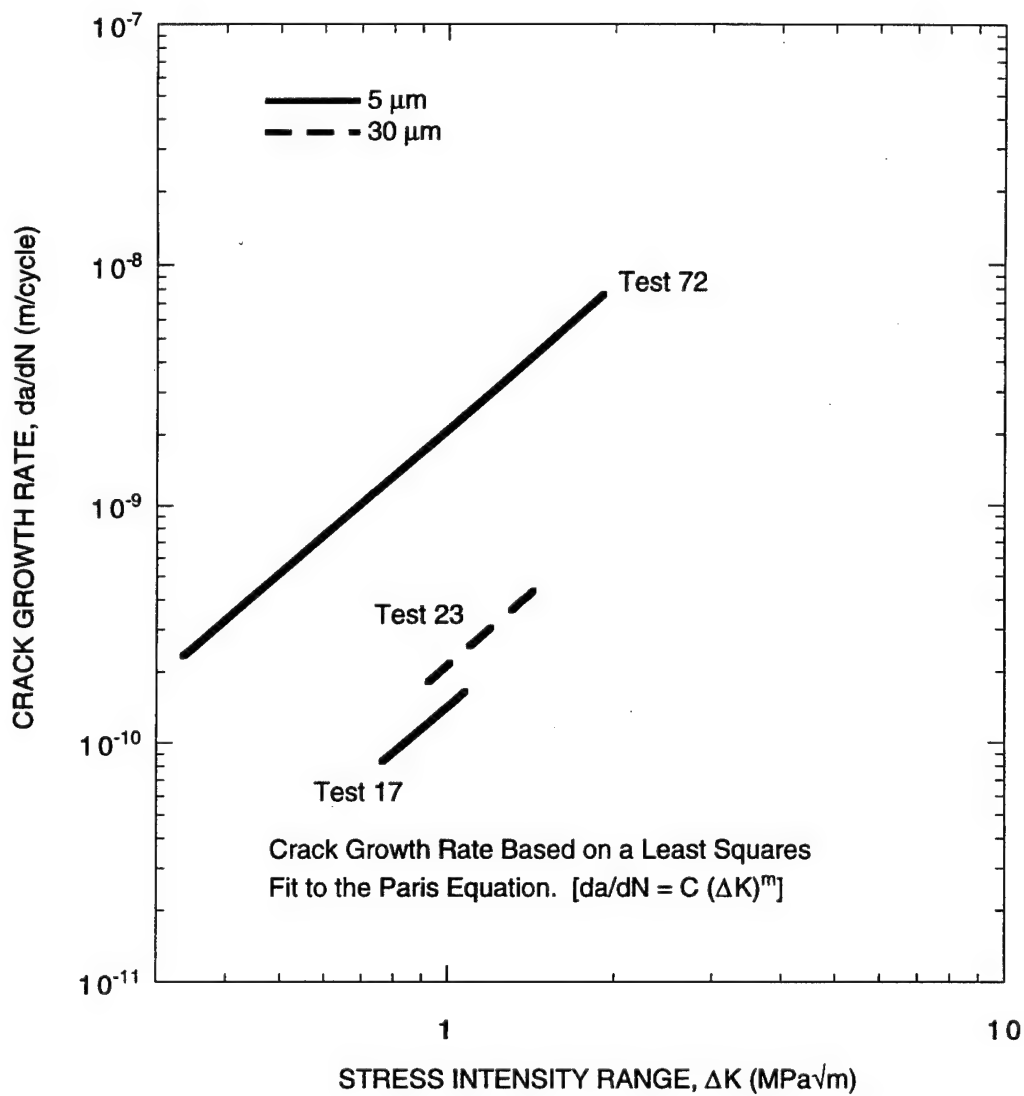
(d) Comparison of specimens in the clad-only condition and in the vertical orientation in the pH 6 environment

Figure 28. Effect of surface roughness on the crack growth rate of small cracks in aircraft skin (Continued).

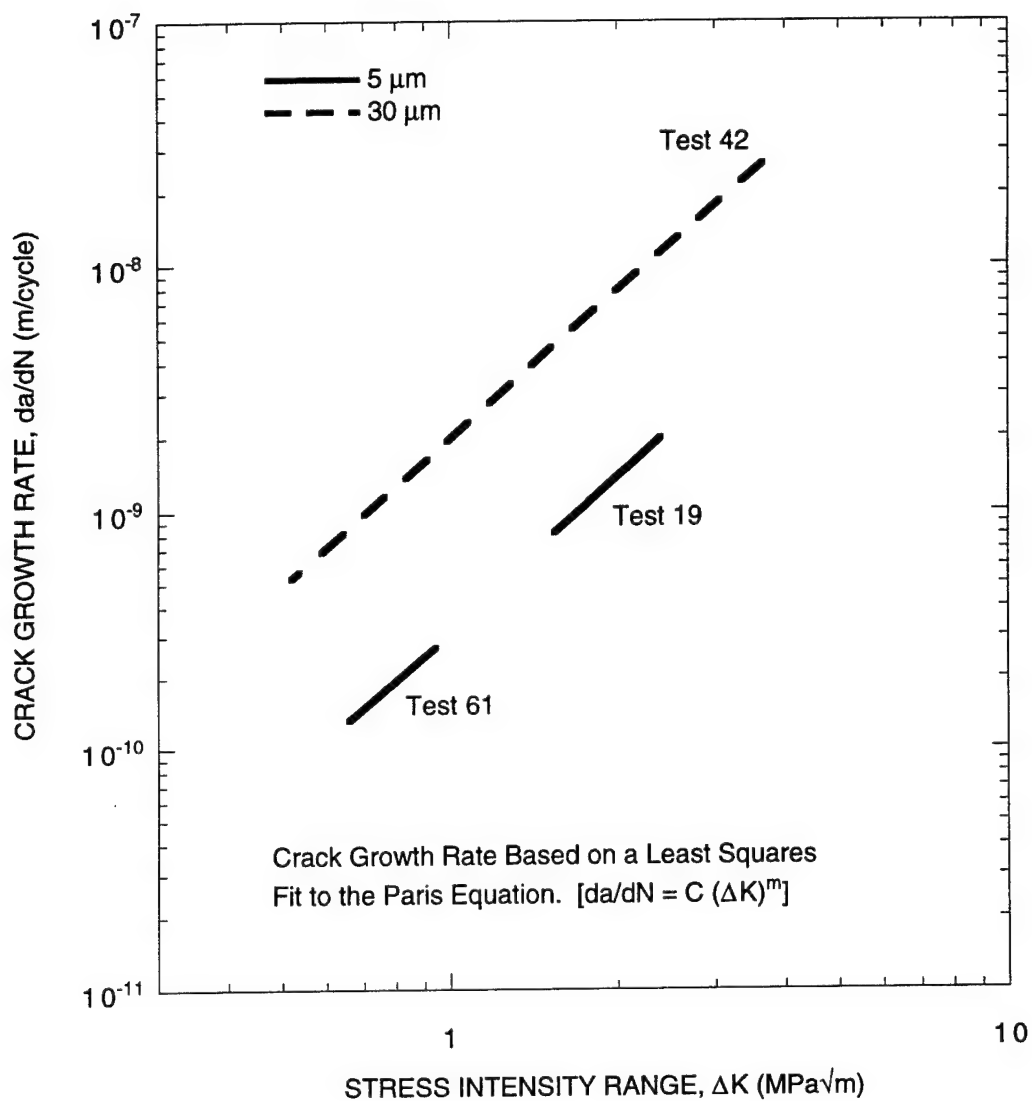
(e) Comparison of specimens in the as-received condition and in the horizontal orientation in the pH 6 environment

Figure 28. Effect of surface roughness on the crack growth rate of small cracks in aircraft skin (Concluded).
